# Turtle Nesting on Adjacent Nourished Beaches with Different Construction Styles: Pinellas County, Florida

DAVIS, R.A.; FITZGERALD, M.V. and TERRY, J., 1999. Turtle Nesting on Adjacent Nourished Beaches with Different Construction Styles: Pinellas County, Florida. *Journal of Coastal Research*, 15(1), 111-120. Royal Palm Beach (Florida), ISSN 0749-0208.

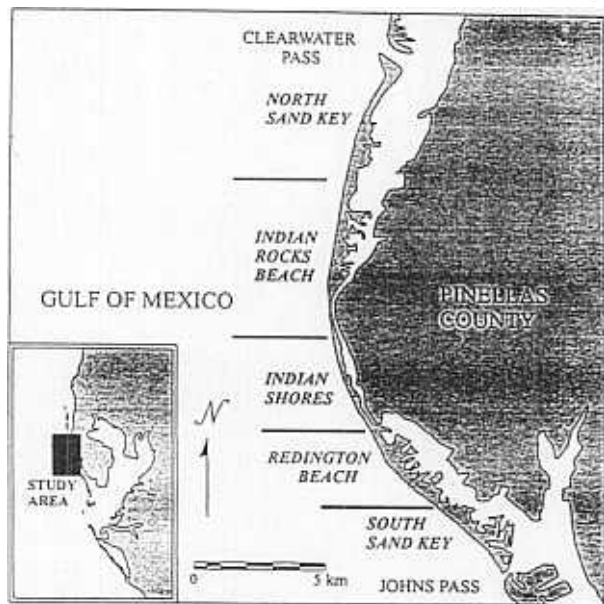
Figure 1. Map of Sand Key, Pinellas County, Florida showing location of the study area.

when it was not (1995). The northernmost nourishment project and the second phase chronologically, Indian Rocks Beach (1990), includes monuments R-72 to R-85. The middle project and the third phase, Indian Shores (1992), includes monuments R-86 to R-98. The southern project was the first completed, Redington Beach (1988), which includes monuments R-99 to R-107 (Figure 1).

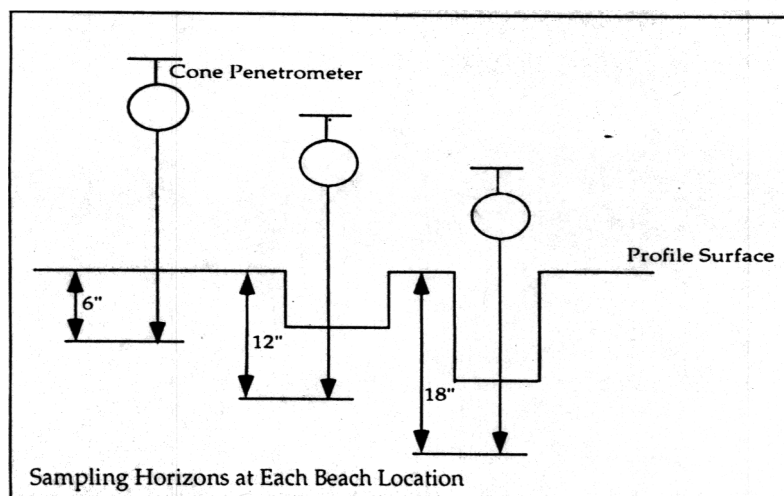
Figure 2. Diagram of portable cone penetrometer used to collect data on resistance to penetration of beach sediment.

Beach monitoring has been a continual process at each of the three nourishment projects. Shear resistance has also been measured as part of this ongoing monitoring. This parameter is measured by a hand-held cone penetrometer (Figure 2) and is commonly used as a proxy for compaction (NEL-

SON, 1987; NELSON and DICKERSON, 1988). The penetrometer has a 0.2 in<sup>2</sup> (1.25 cm<sup>2</sup>), 30-degree, circular cone and a dial ranging from 0–1000 cone index units (pounds per square inch–psi). The penetrometer is held in the vertical position and manually pushed into the beach sediment. The commonly accepted technique is to take measurements at 6, 12 and 18 inches (approx. 15, 30 and 45 cm respectively) (e.g. NELSON and DICKERSON, 1988).

be the nature of the cone penetrometer and the accuracy of its measurements. Temperature differences of the metal could cause changes in the resistance to deformation of the stainless steel ring on the penetrometer (Figure 2) although this would be expected to be quite small.

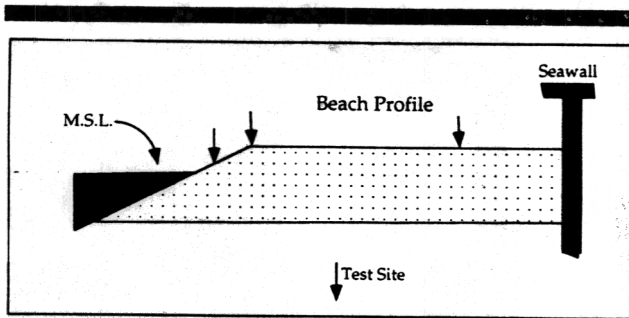
Figure 3. Schematic diagram of a beach profile showing locations of sampling sites along each profile.

Each of 40 beach profiles was visited 4 times per year for two years (1994–95). Penetrometer measurements were taken at each of three sites along all profiles; in the swash zone, at the berm crest, and in the back beach, Gulfward of the foredunes, seawall or other structure (Figure 3). The 6 inch (15 cm) reading was taken as the penetrometer was inserted from the surface to a depth of 6 in (15 cm). A hole was excavated to 6 inches (15 cm) and the penetrometer was inserted an additional 6 inches (15 cm); a total depth of 12 in (30 cm). The same procedure was conducted for the 18-inch (45 cm) measurement. All measurements that exceeded the values on the dial of the penetrometer are considered to be 1000.

and with depth. Because of the dynamics of the foreshore zone coupled with the absence of turtle nesting in that zone and in the berm crest, these data are not considered in this discussion. Only data from the backbeach are discussed (Figure 3).

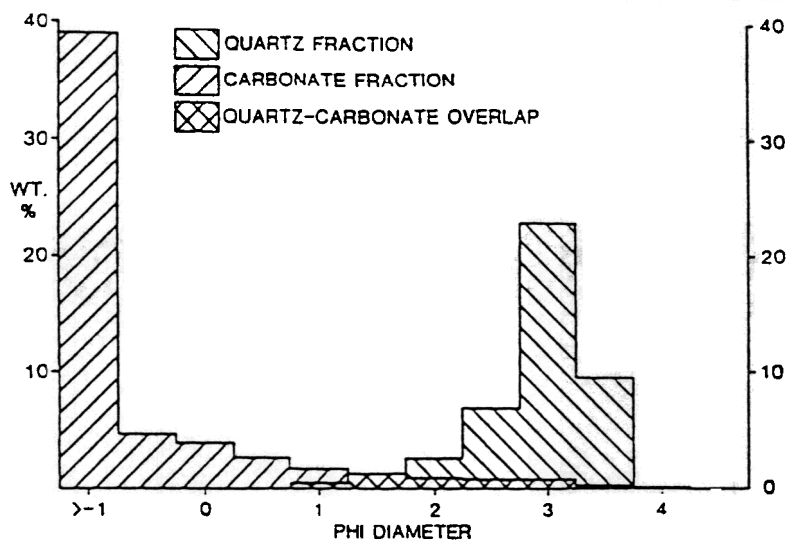
Figure 4. Histogram showing typical bimodal sediment that occurs along this part of the Florida coast with one mode being fine quartz sand and the other comprised of coarser shell debris.

Sediments along the peninsular Florida Gulf Coast are distinctly bimodal in both grain size and composition. They are comprised of a fine sand quartz fraction and a medium sand to gravel biogenic shell fraction. The quartz fraction is dominant at most locations and the shelly fraction is typically the variable. This fraction tends to be granule to fine cobble in size and varies in both location and time. A typical percentage of shell gravel is 10–15% for natural beaches but is generally higher for borrow material used on nourished beaches. There is commonly a sand fraction of carbonate shell also. The distribution of both grain size and composition is shown by an example from Pinellas County (Figure 4).

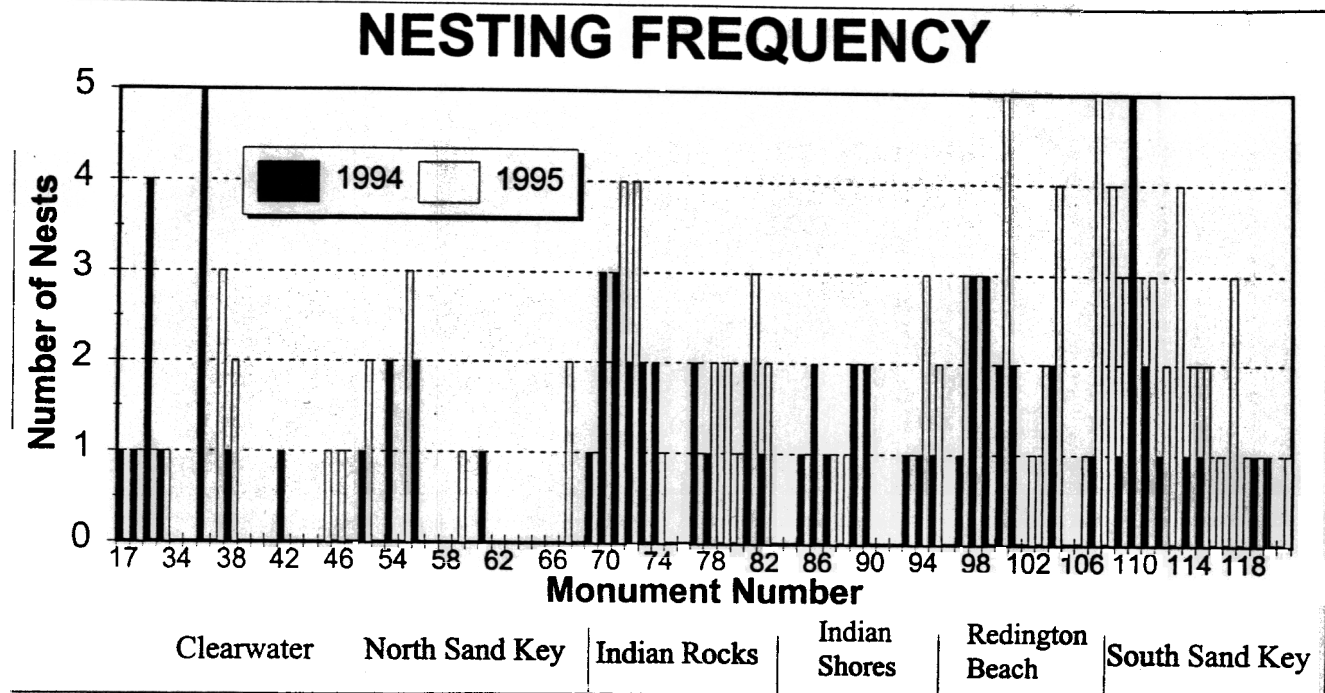
Figure 5. Nesting frequency by R-location on Sand Key, Florida. Each numbered beach segment is 1000 feet (306 m) apart. Each nest was placed on this diagram at the closest of these DEP monuments. (Data from Harman, 1994; 1995).

Counts of the number of nests in each of these five beach segments over the two-year period (HARMAN, 1994; 1995) show that the relative frequency is similar in each (Figure 5). These data also show that there is some difference in nest frequency among the three nourishment projects. Within this

shoreline investigated, there were 62 nests in 1994 and 88 in 1995. In both years there were more nests at Indian Rocks and Redington than there were at Indian Shores (Figure 5). Indian Shores was the only segment where tilling of the beach was conducted and that was done only in 1994.

Notice that the Bellair area (R55-70; Figure 5) has a much lower nest frequency than the other four with only 3 nests each year. The reason for this situation is a simple one. There is essentially no dry beach along this reach of shoreline. This area has not been nourished and it has not gained much sediment from end loss as a result of littoral drift from the Indian Rocks Beach project located immediately to the south. The opposite situation has occurred at the south end of the project at the south end of Sand Key (Figure 5) where there is a substantial dry beach with the resulting increase in turtle nest density.

The higher nesting frequency occurs in the beach nourishment segments that have the highest shell concentration and the highest compaction (Figure 5), *i.e.* Indian Rocks Beach and Redington Beach. We do not believe that the turtles are preferentially selecting the more compact beach for nesting but that the values are artificially elevated due to the orientation of the shells, and the method of nourishing the beaches. The absence of any slurry pumping at Indian Shores produced a constructed beach that was less compacted from its initial construction. This is demonstrated by the summary histograms that cover all three depths of measurements at all three nourished beach reaches for both of the study years (Figure 10). This clearly shows that Indian Shores penetration values are lower throughout the study with the possible exception of the June, 1994 surveys which were after tilling. This figure also shows that the vast majority of locations throughout all three projects have values above the 500 psi level most of the time.

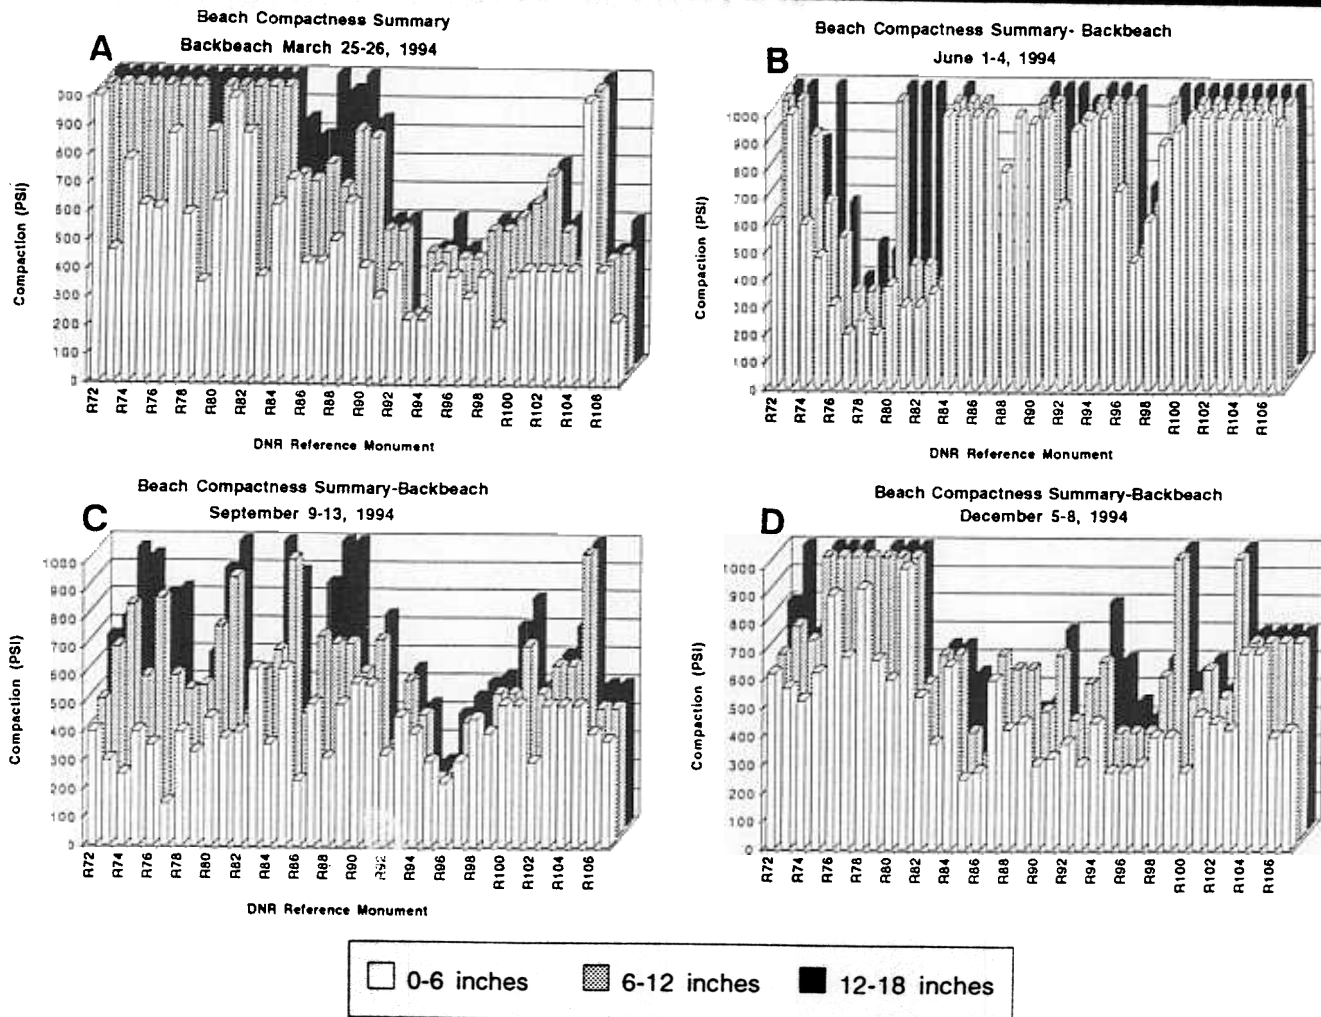
Figure 6. Resistance to penetration at each location by depth for 1994. Each bar on the histogram represents one measurement and this diagram shows all data collected.

There are two primary ways of looking at these data. One is to consider the values at individual sites during each surveying period (*e.g.* Figure 6) and the other is to look at mean values for each of the three phases of nourishment (*e.g.* Figure 7). The former illustrates well the rather wide range of variation within the study area but the latter shows the average differences, if any, between adjacent nourishment projects. The usual statistical treatments are not applicable because of the combination of the small samples at each nourishment project ( $n = 9-14$ ), and the large standard deviation among the readings.

1994—Data from this year show that in June, just prior to tilling, the compactness was variable in the Indian Rocks segment and nearly uniformly high throughout the other two areas (Figure 6A). After tilling of the Indian Shores segment only, there was a marked reduction in the compactness of that segment as shown by the September data (Figure 6B).

The most compacted segments are at Indian Rocks and Redington (Figures 6–9). Both of these segments were constructed by suction dredge and pumping in a slurry onto the beach. In addition, both of these segments have sediments that have relatively high percentages of shell gravel com-

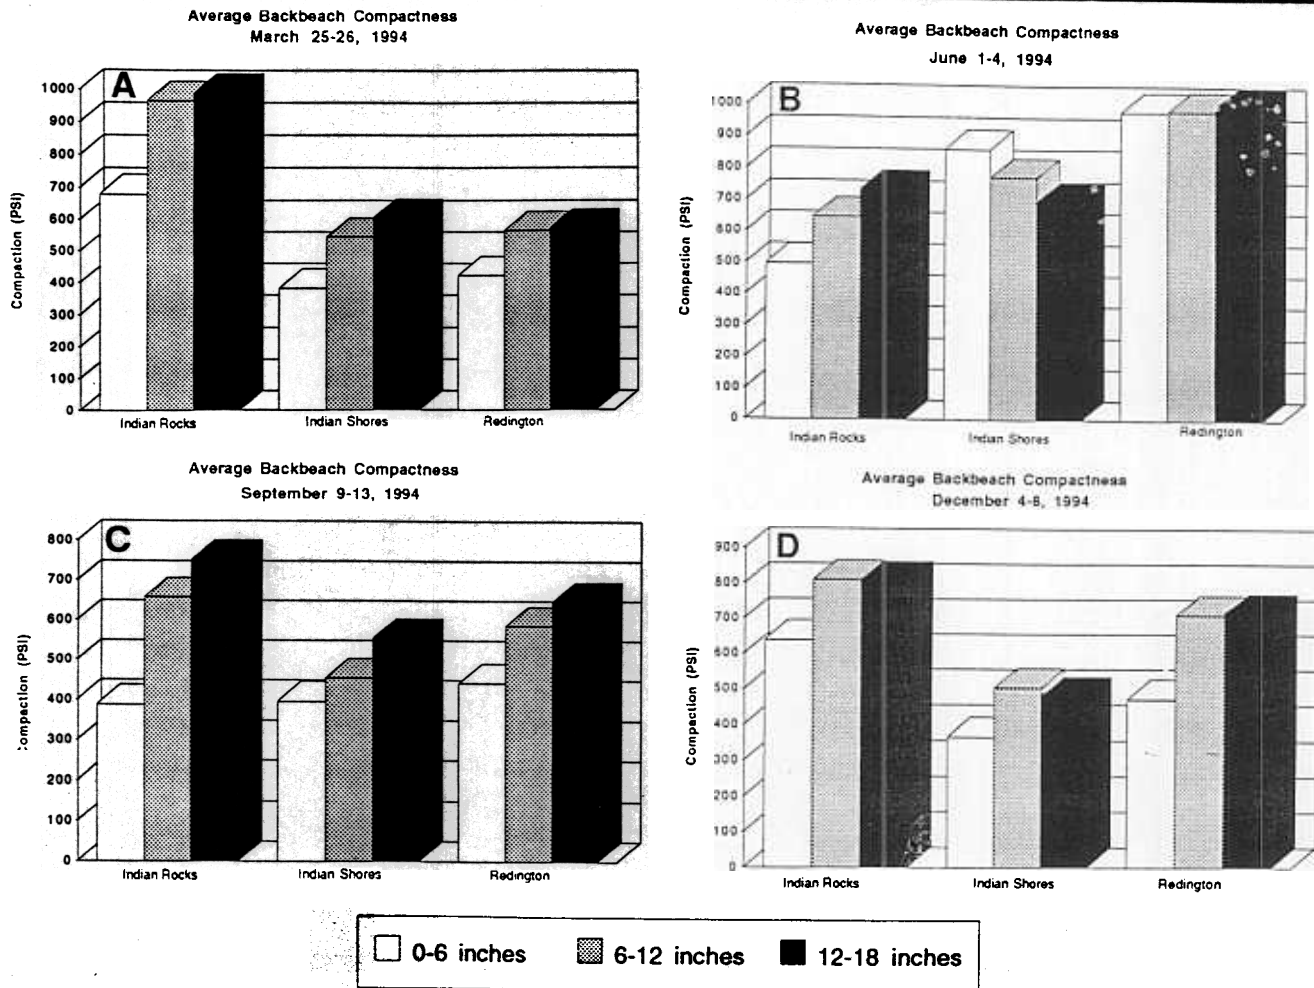
Figure 7. Resistance to penetration by nourishment segment for 1994. Each bar on the histogram represents the mean value for each depth at all locations within a given beach nourishment project (IRB  $n = 14$ , IS  $n = 13$ , RB  $n = 9$ ).

The summarized data for 1994 for each segment of the three nourishment projects (Figure 7) show that in the early part of the nesting season the Redington segment was very highly compacted, the Indian Shores less and Indian Rocks was the least compacted of the three nourished segments (Figure 7A). Tilling took place shortly after these data were collected and showed a modest reduction in the compactness of the Indian Shores segment (Figure 7B) however, the Redington segment showed a greater reduction without benefit of tilling. Indian Rocks displayed a marked increase in compaction over the same period (Figure 7B). By December, Indian Shores showed further reduction in compaction, and In-

dian Rocks and Redington were the same as in September (Figure 7 B and C).

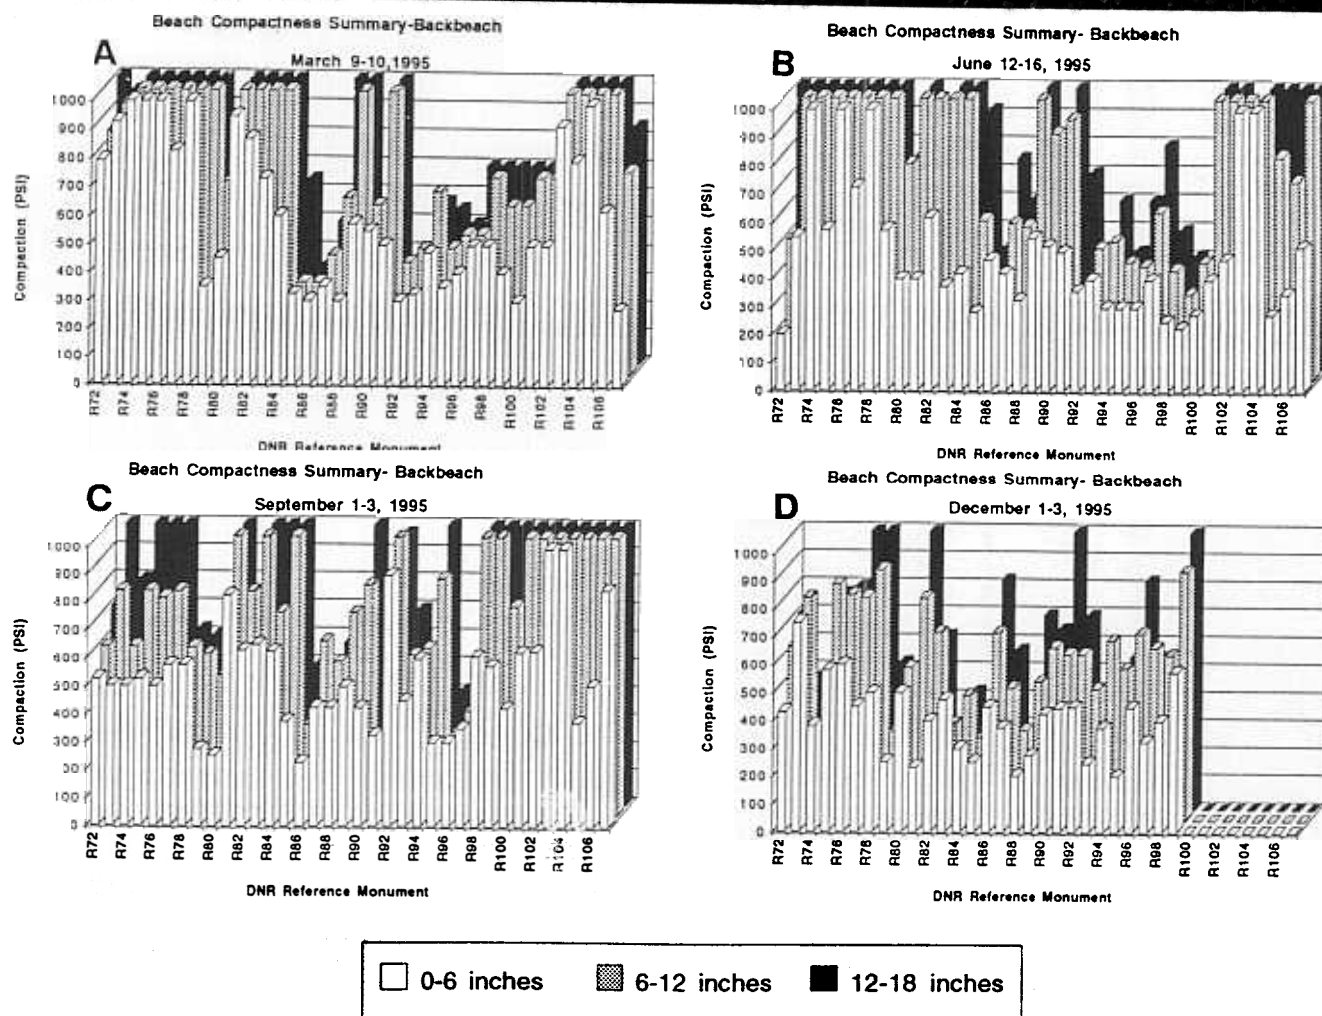
Figure 8. Resistance to penetration at each location by depth for 1995. Each bar on the histogram represents one measurement and this diagram shows all data collected.

sampling periods (Figure 8). This also holds for the relative compactness values at adjacent projects during a given sampling period.

**1995**—The 1995 data for each of the profile locations also show great spatial variability but less temporal change than the 1994 data (*cf* Figures 8 and 9). During March there was a rather uniformly highly compacted condition at Indian Rocks (R72-85) and quite a range of compactness throughout the other two segments (Figure 8A). The June data show a generally similar pattern but with more compaction at the Indian Shores (R85-98) and Reddington (R99-107) segments (Figure 8B and C). September data also show great range but with less uniform and severe compaction in the Indian Rocks segment and more at the Redington segment; the Indian Shores segment was about the same.

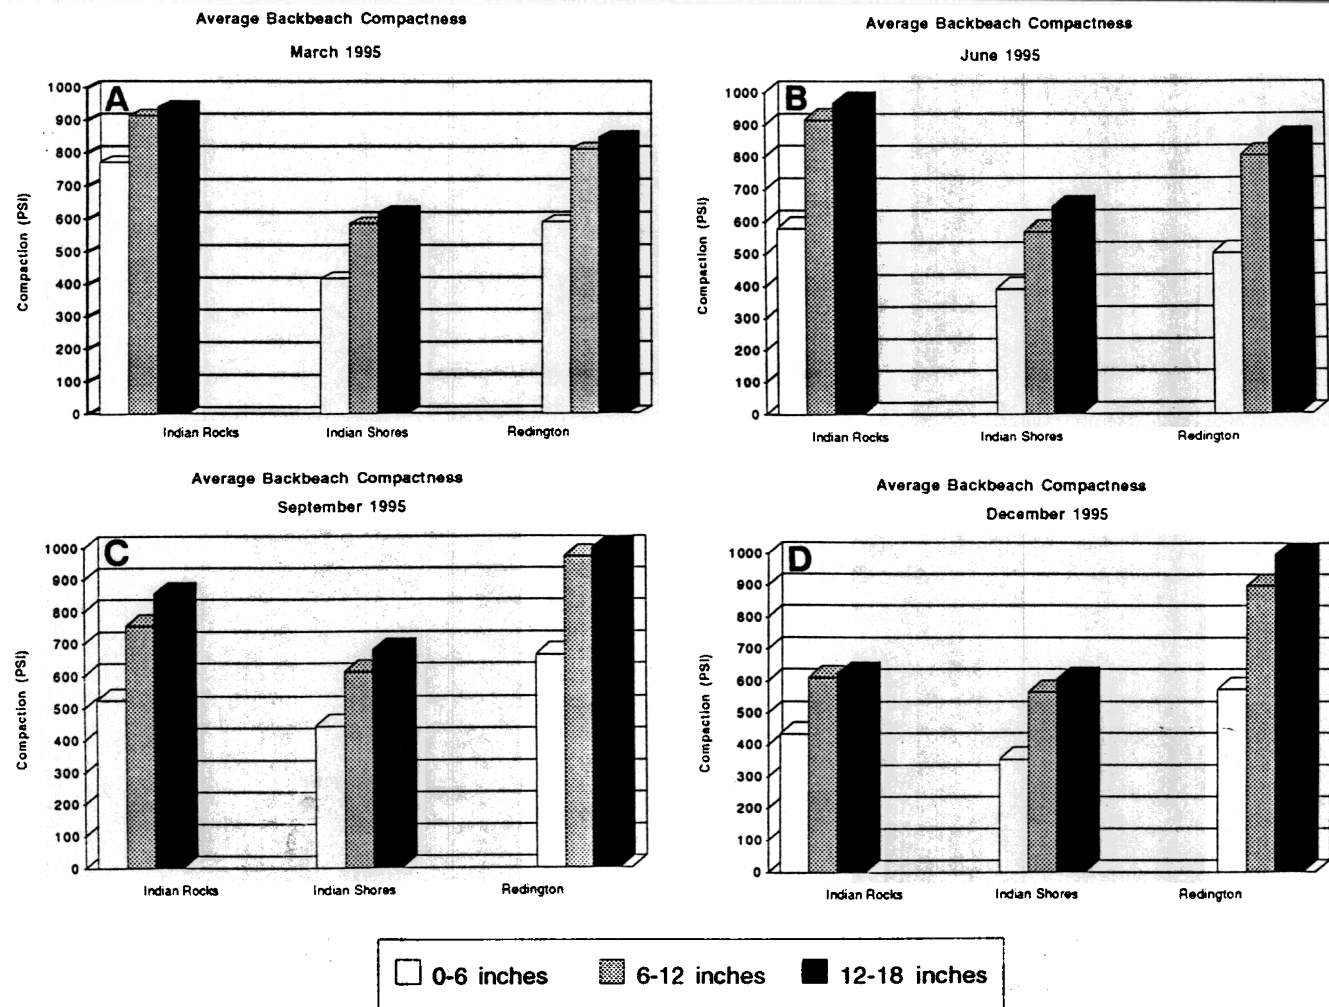
Figure 9. Resistance to penetration by nourishment segment for 1995. Each bar on the histogram represents the mean value for each depth at all locations within a given beach nourishment project (IRB n = 14, IS n = 13, RB n = 9).

The summary data by segment for 1995 show distinct patterns and some expected relationships. The March compaction readings (Figure 9A) clearly show that the Redington segment has the highest mean values and the Indian Shores

segment has the lowest. The June data (Figure 9B) show the same pattern. The September data display a modest departure from this pattern in that the Redington segment had the highest compaction; Indian Shores was the lowest (Figure 9C). Throughout the period of monitoring the Indian Shores segment has shown the greatest rate of erosion (DAVIS *et al.*, 1993). It is also the most recently completed nourishment project of the three investigated.

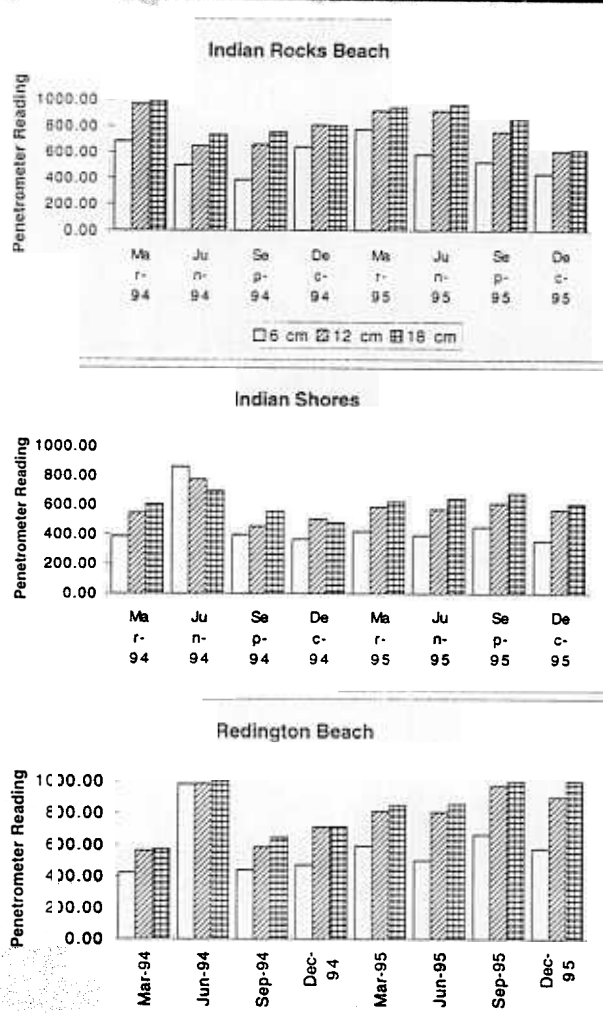
Figure 10. Plots of mean penetrometer readings in the backshore of the beach at each nourishment project over the two-year study period. Each value represents the following individual sites: Indian Rocks Beach,  $n = 14$ , Indian Shores,  $n = 13$ , Redington Beach,  $n = 9$ . The horizontal line represents 500 psi.
